Using 3D imaging to map bullet impacts in sandstone

Lisa Mol^{1,2}, Miguel Gomez-Heras³, Charlotte Brassey⁴, Owen Green⁵, Tom Blenkinsop⁶

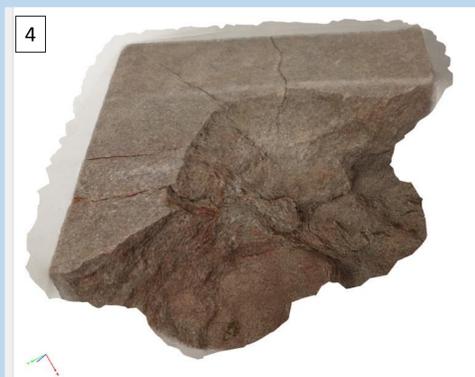
Figure 4: 3D scan of AK103 impact

Initially sandstone samples were shot with an AK-103, which resulted in large scale fracturing of the sample (see figure 4) and rendered the samples unusable for environmental stress tests. Smaller .22 caliber lead bullets were therefore used to create contained fracture network impact sites with a Hornet rifle at 200m distance (see figure 5).

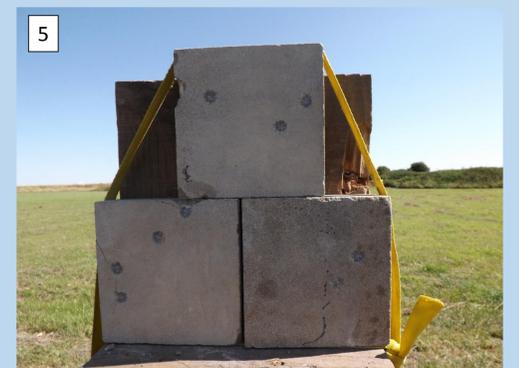
Figure 5: .22 caliber lead bullet impacts at the Caldicot rifle range
